Energy Efficiency for Tarachand Hospital A Case Study at Pune, Maharashtra, India.

Young Researcher's Conference, WSED, Austria, 2016

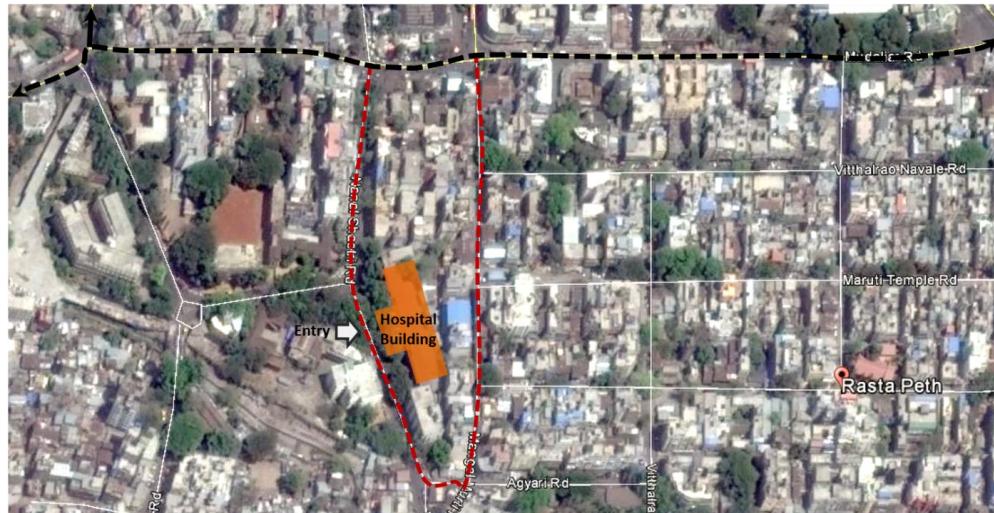
Source: Google earth dated 01.10.2015

Tarachand hospital, a G+2 structure is located in Rasta Peth of Pune city, Maharashtra, India. The main access to the site is from the west. More vegetation is observed towards its western side. The hospital building is located in dense area surrounded by buildings on all sides, which becomes a challenge in terms of daylight and ventilation aspects.

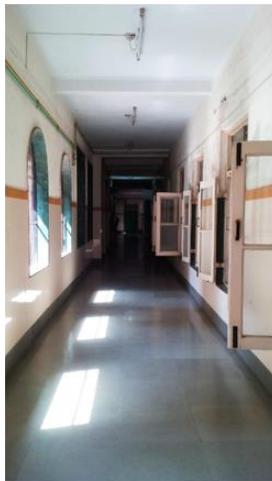
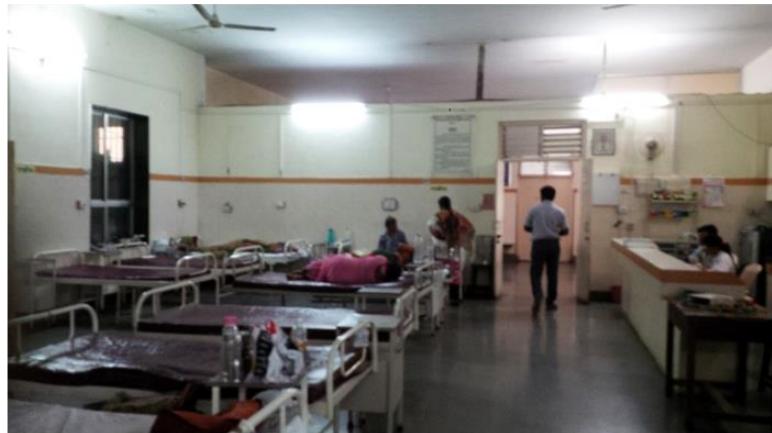
More use of artificial lighting in wards

Corridors along wards on the western side, reducing the light intensity in the wards.

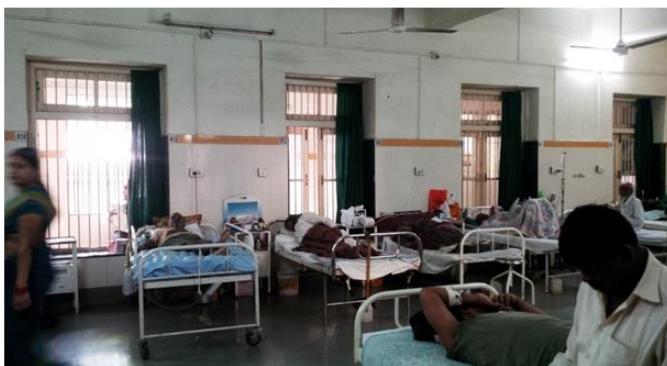
Glare from windows facing west

The windows of the west side of building experiences glare which disturbs the wards. To avoid this glare, double skin wall with insulation and shading of devices are recommended which will help to bring good quality of light in wards and thereby also maintaining indoor air quality.

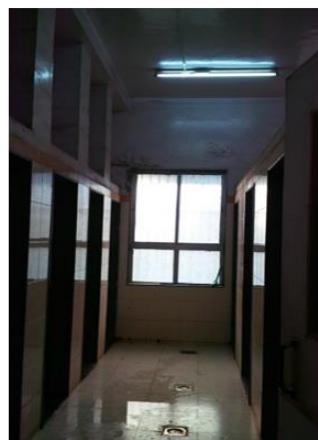
Toilets

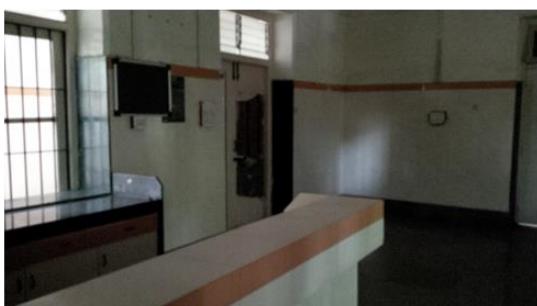
No much natural light from west side

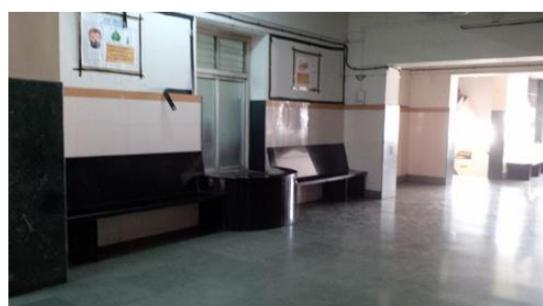
Main Lobby areas with less natural light

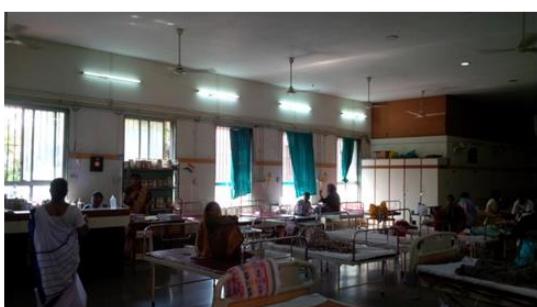
More use of artificial lights in wards due to corridors on the periphery

The central area of hospital comprising of mainly general wards, lobby areas gets less daylight. Hence modern energy efficient devices like CFL, LED's are recommended which save 50%-80% energy even if it comes under artificial lighting. Occupancy sensors save 50% energy savings. Daylight sensors are recommended to turn lights on and off and also dim lights when sufficient daylight is available in circulation areas like corridors. Presence detectors are recommended wherever variable occupancy occurs such as smaller areas like toilets, equipment stores, medical record stores etc. Zoned daylighting is recommended where lighting can be adjusted according to daylight availability by switching to 'off' for larger areas like special rooms etc.

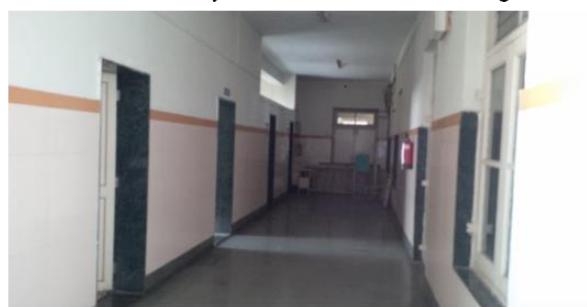
Corridors with no light and ventilation

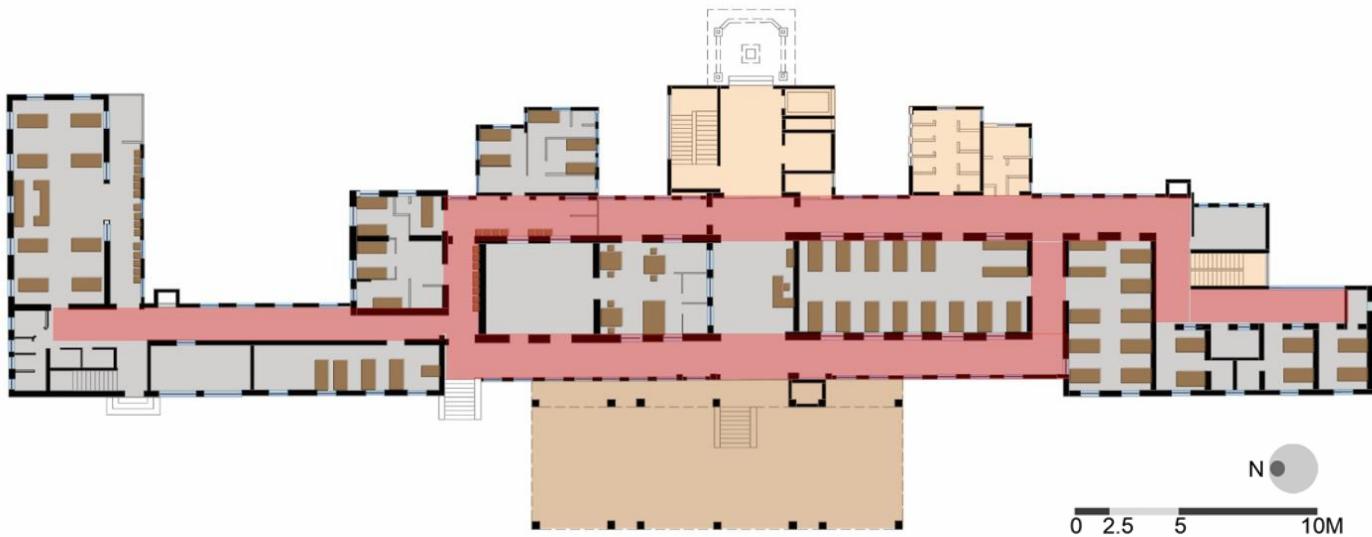
6.1. Corridors

Corridors on all the sides of the general ward, leads to compromise in natural light, ventilation and waste of space. Area under passage is 27% of floor area, which is above recommended standards (STD.15% maximum.). More of artificial lighting is thus used which results in more energy consumption. Due to the Operation theatre block on the west side, corridors experience lack of air movement and less natural light.

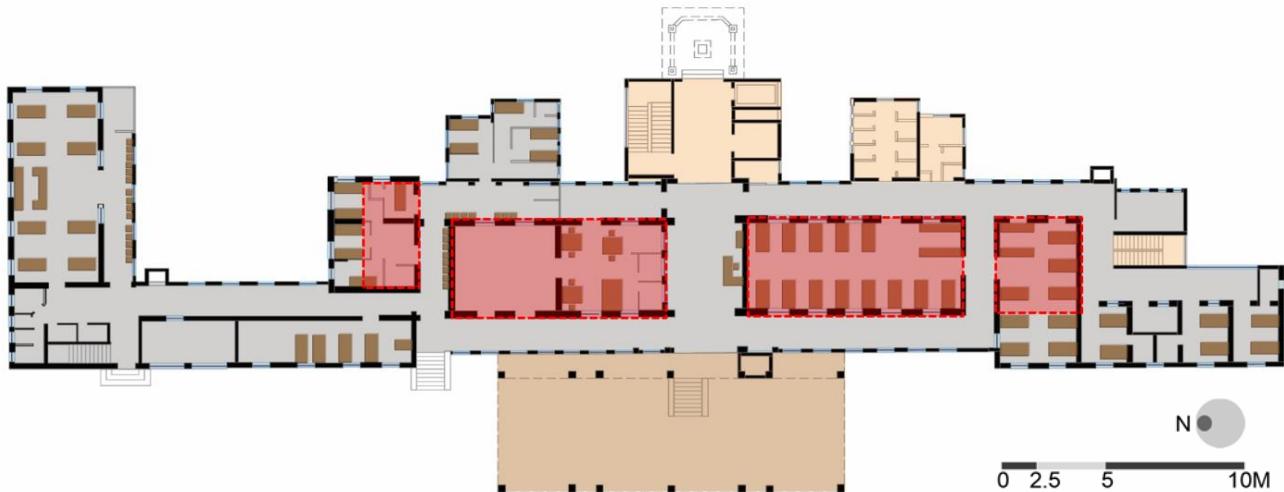
6.2. Daylight and Ventilation

As corridors are surrounding the wards from all sides, the external walls of wards are not exposed directly to natural daylight. Less daylight and ventilation in common wards is thus observed which results in dependency on artificial lighting, increasing in energy consumption.

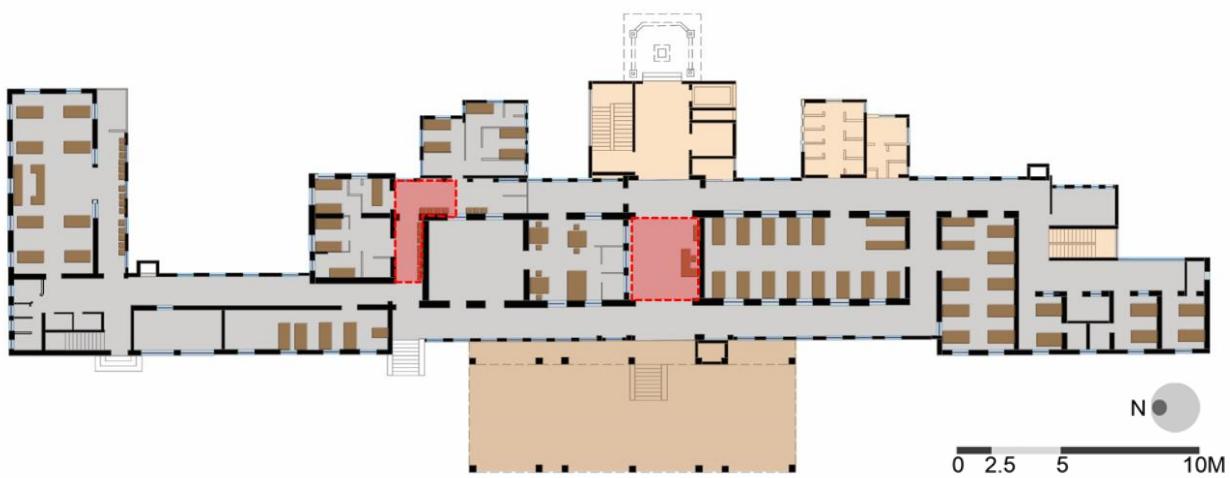
6.3 Lobby and Waiting areas

Due to increase in number of patients, new functional spaces were added in hospital building on later stage which resulted into transformation of lobby areas into waiting areas on all the floors. So the hospital lacks in proper designated waiting areas.

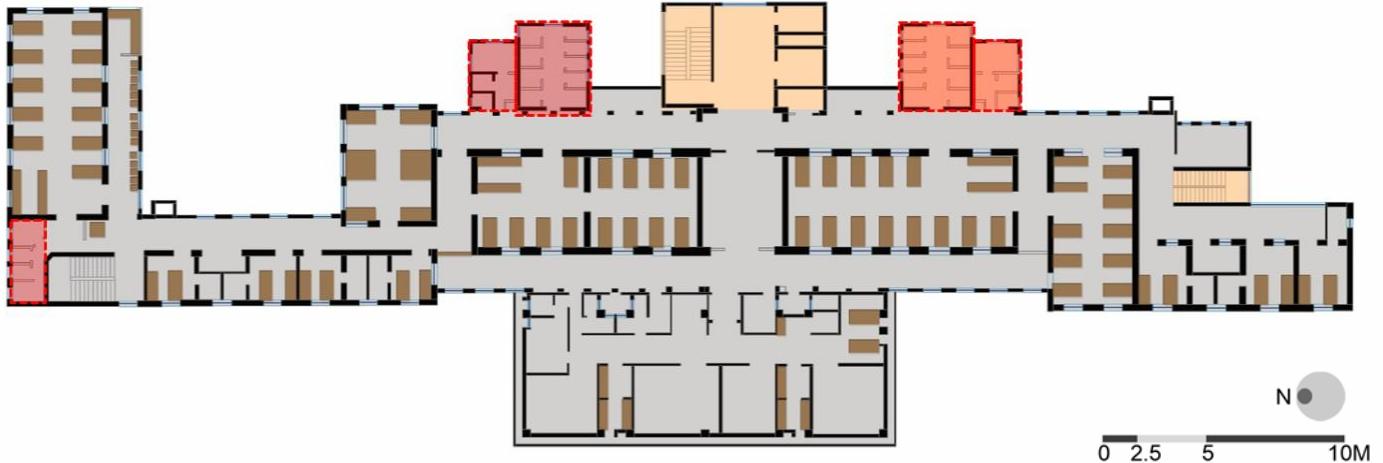
6.4. Toilet Locations

The toilets were constructed later on which create an obstruction to natural daylight. Location of toilet towards east side resulted into blocking of morning sunlight, reducing daylight in wards. Location of toilet towards north-west side is in wind direction which causes foul smell.
